Hensley Home Check, LLC

Summary

Client(s): **Mr. And Mrs. Homebuyer**
Property address: **111 Anywhere, USA**
Inspection date: **Sunday, April 17, 2016**

Property Inspection Report

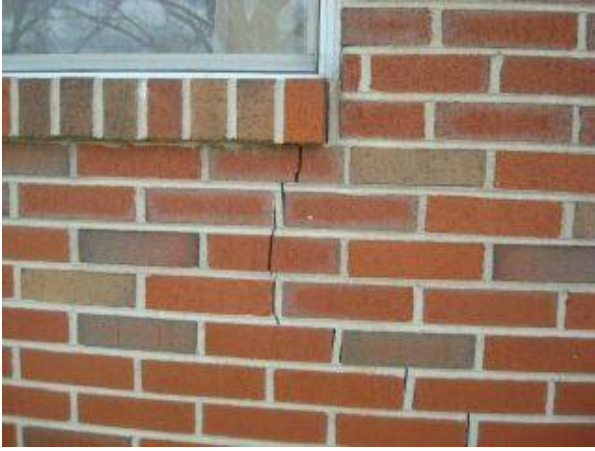
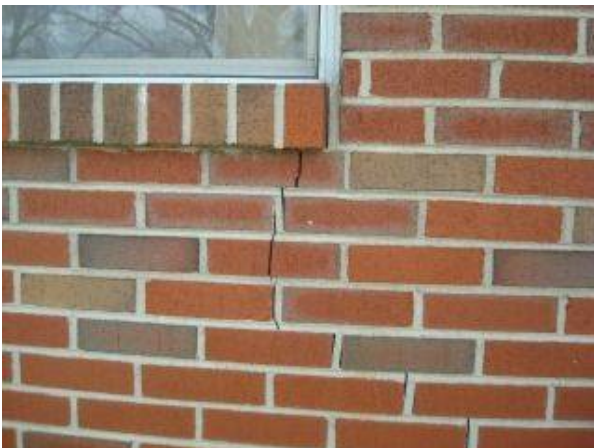
Photo 1-1

- 1 🛠️ - The brick veneer was cracked in one area. Recommend that a qualified contractor repair as necessary by caulking or reprinting the brick.

The brick veneer was cracked in one area. Recommend that a qualified contractor repair as necessary by caulking or reprinting the brick.

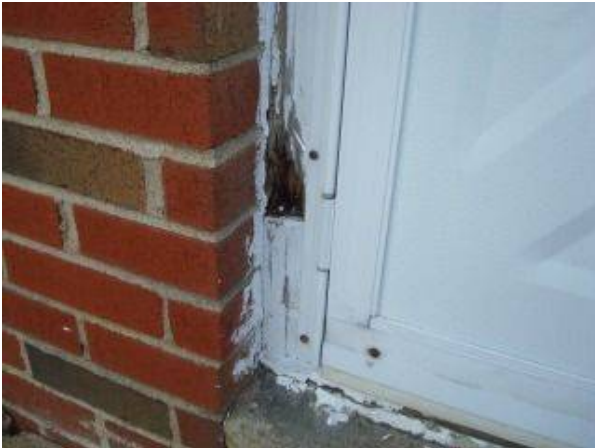
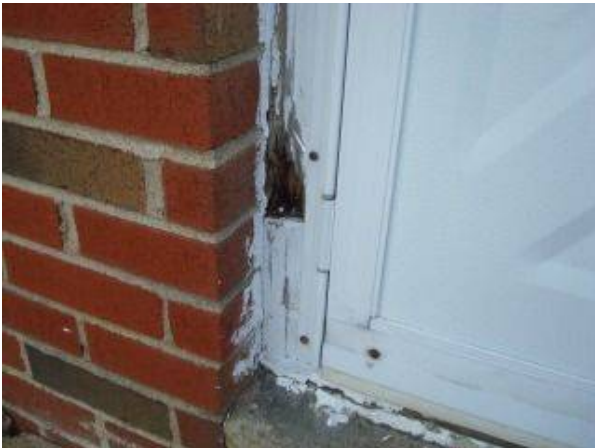
Photo 2-1

- 2 🛠️ 🔍 - Damage to outside door frame. Recommend repair.

Damage to outside door frame. Recommend repair.

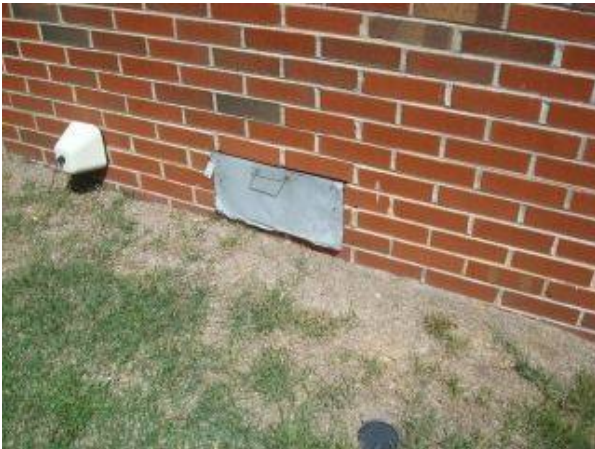
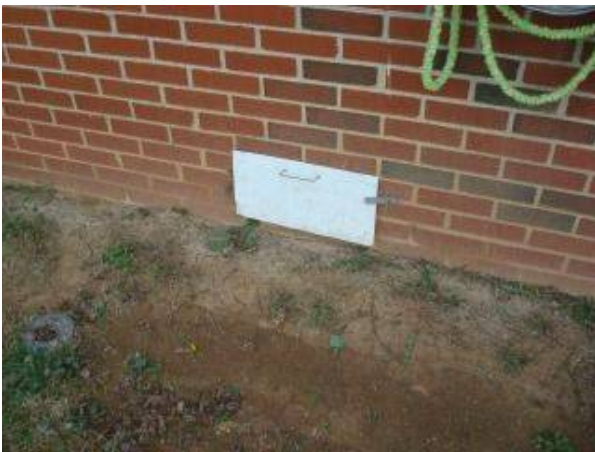
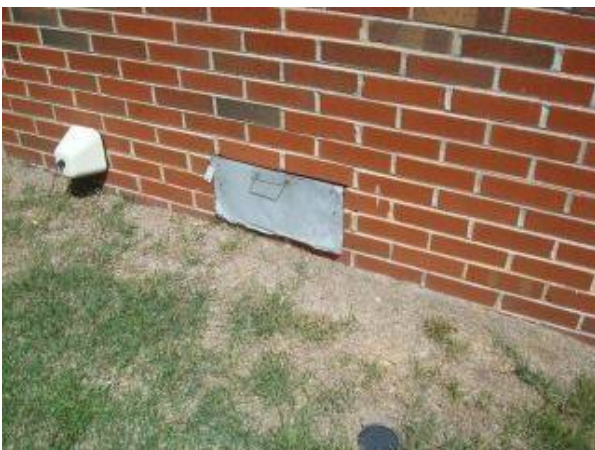
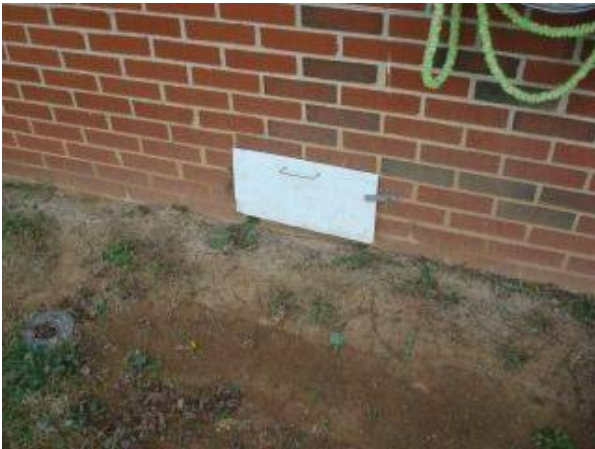
- 3 ⓘ - One or more crawl space vents were intentionally blocked. This restricts ventilation in the crawl space and can result in increased levels of moisture inside. Such vents should be left open at all times except during severe freezing weather. Recommend removing materials or items blocking vents as necessary.

One or more crawl space vents were intentionally blocked. This restricts ventilation in the crawl space and can result in increased levels of moisture inside. Such vents should be left open at all times except during severe freezing weather. Recommend removing materials or items blocking vents as necessary.

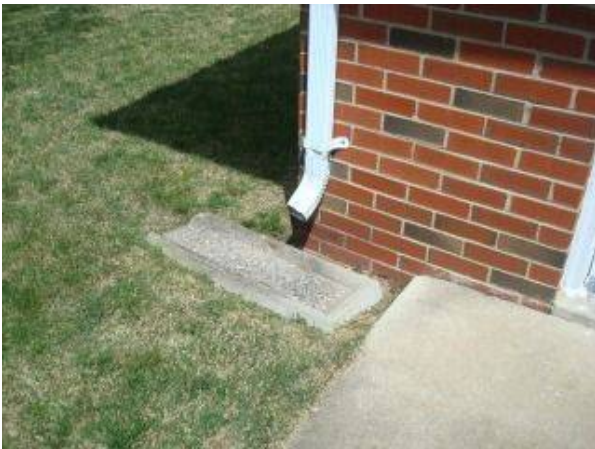
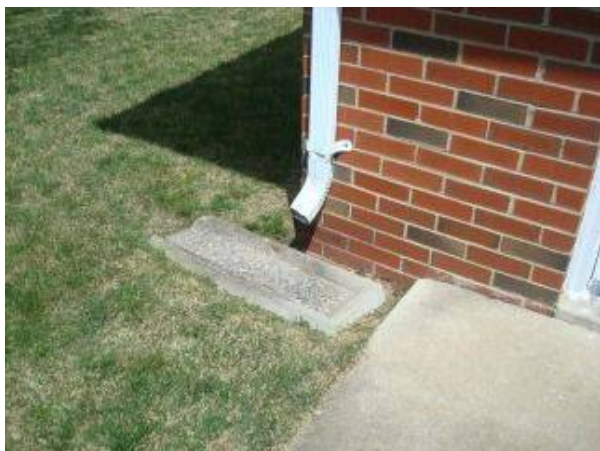
Photo 5-1

- Recommend extending downspout so the rainwater is discharged 5' from the homes exterior.

-
- 5) 🛠️ Recommend extending downspout so the rainwater is discharged 5' from the homes exterior.

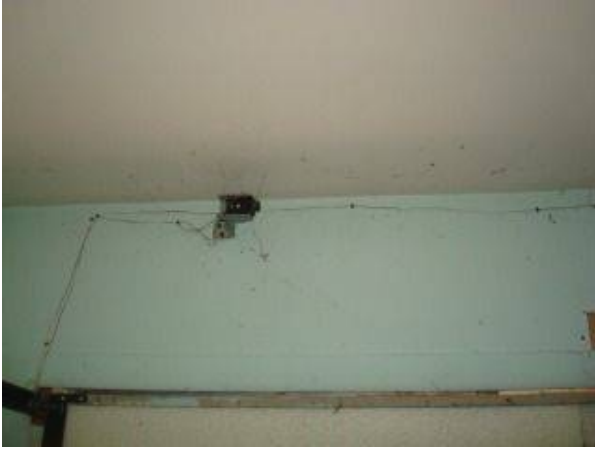
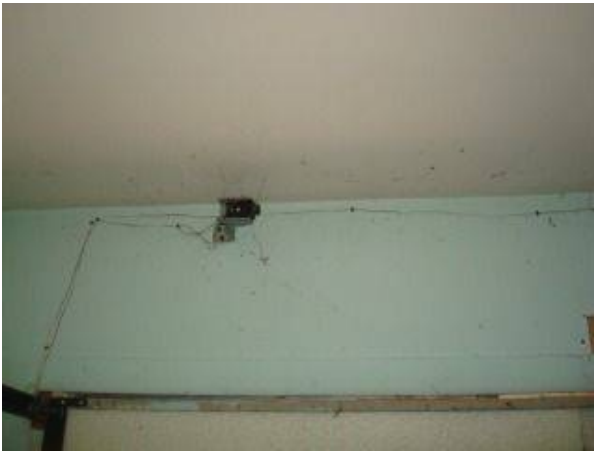
Photo 8-1

- The photoelectric sensors that trigger the auto-reverse feature on the garage vehicle door automatic opener were located higher than 4-6 inches from the floor. This is a potential safety hazard. A qualified person should relocate sensors so they are 4-6 inches from the floor per standard building practices.

The photoelectric sensors that trigger the auto-reverse feature on the garage vehicle door automatic opener were located higher than 4-6 inches from the floor. This is a potential safety hazard. A qualified person should relocate sensors so they are 4-6 inches from the floor per standard building practices.

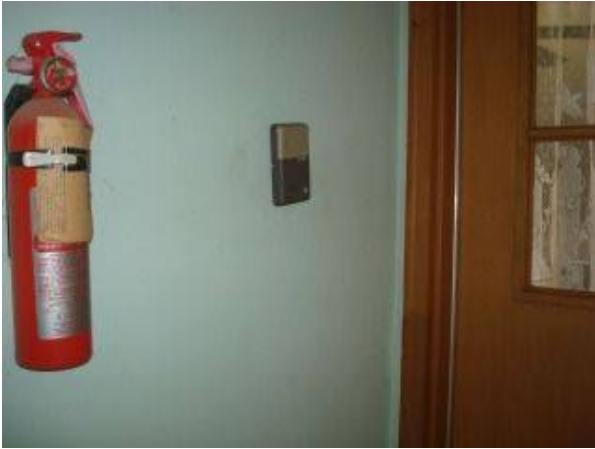
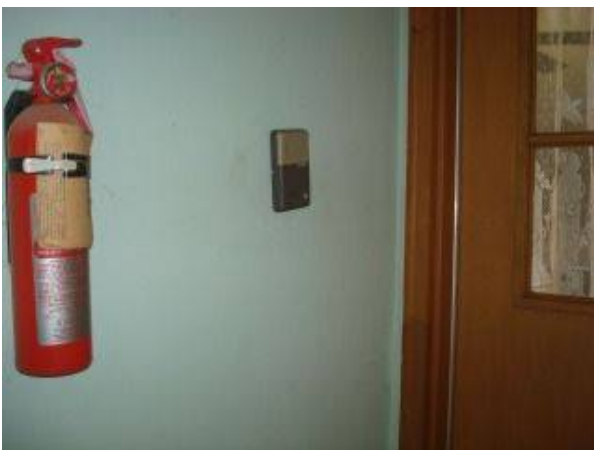
Photo 9-1

- The control button for operating the automatic garage vehicle door opener was loose. Recommend re-securing button to the wall.

The control button for operating the automatic garage vehicle door opener was loose. Recommend re-securing button to the wall.

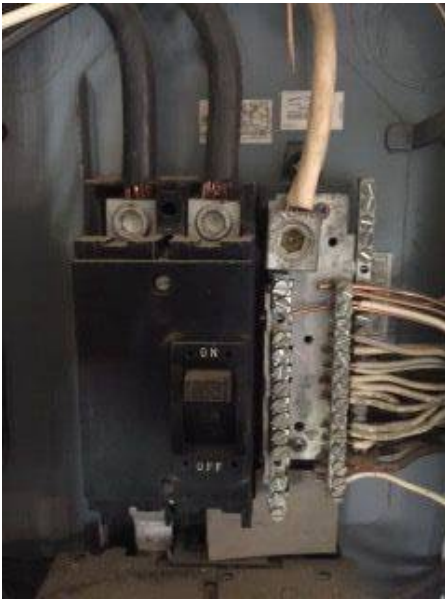
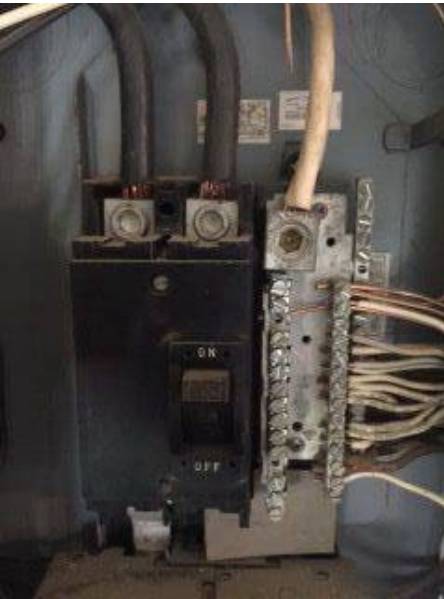
Photo 11-1

- One or more circuit breakers in panel(s) #A were "double tapped," where two or more wires were installed in the breaker's lug. Most breakers are designed for only one wire to be connected. Recommend that a qualified electrician repair as necessary.

One or more circuit breakers in panel(s) #A were "double tapped," where two or more wires were installed in the breaker's lug. Most breakers are designed for only one wire to be connected. Recommend that a qualified electrician repair as necessary.

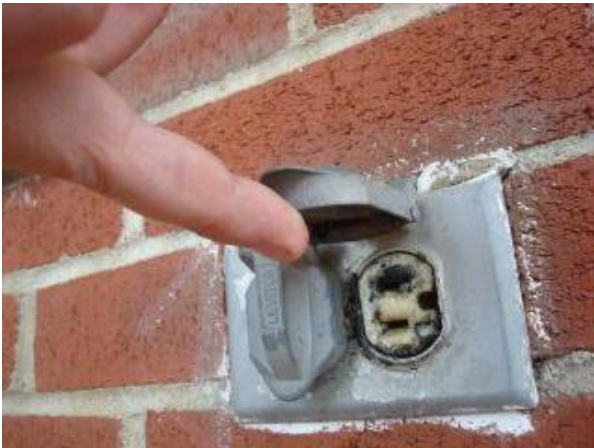
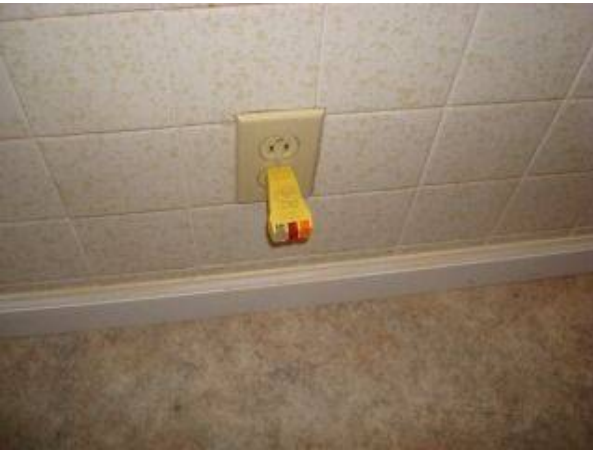
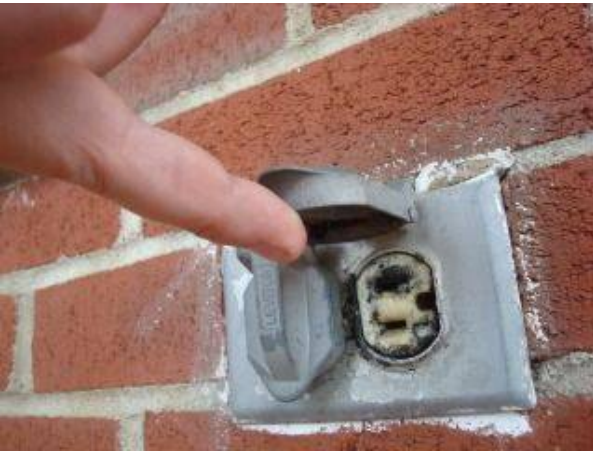
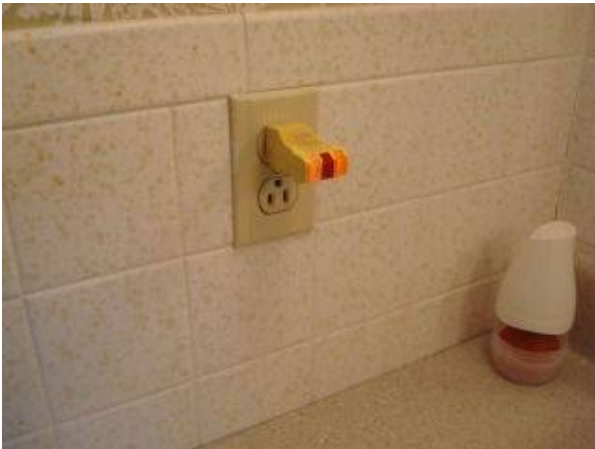
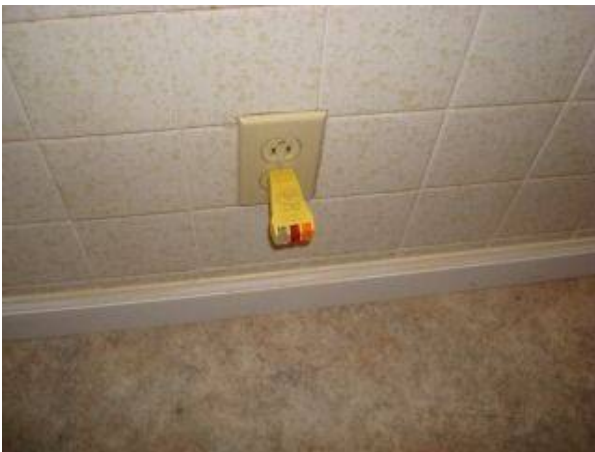
- One or more electric receptacles at the kitchen, full bath and/or garage had no visible ground fault circuit interrupter (GFCI) protection. Receptacles within six feet of interior plumbing fixtures, and all receptacles in the garage or carport, and on the exterior of the home should be GFCI protected. If not GFCI-protected, receptacles in wet areas pose a shock hazard. Recommend that a qualified electrician evaluate and install GFCI protection if necessary and per standard building practices.

One or more electric receptacles at the kitchen, full bath and/or garage had no visible ground fault circuit interrupter (GFCI) protection. Receptacles within six feet of interior plumbing fixtures, and all receptacles in the garage or carport, and on the exterior of the home should be GFCI protected. If not GFCI-protected, receptacles in wet areas pose a shock hazard. Recommend that a qualified electrician evaluate and install GFCI protection if necessary and per standard building practices.

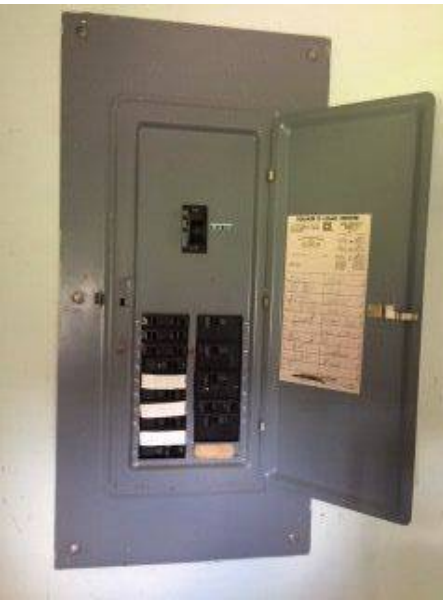
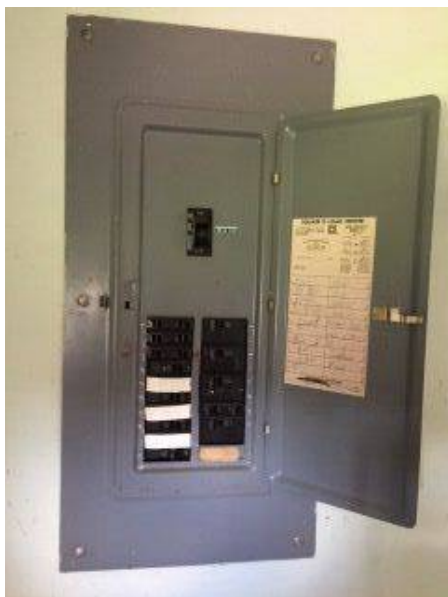
Photo 14-1

- One or more slots where circuit breakers are normally installed were open in panel(s) #A. Energized equipment was exposed and is a shock hazard. Recommend that a qualified person install closure covers where missing.

One or more slots where circuit breakers are normally installed were open in panel(s) #A. Energized equipment was exposed and is a shock hazard. Recommend that a qualified person install closure covers where missing.

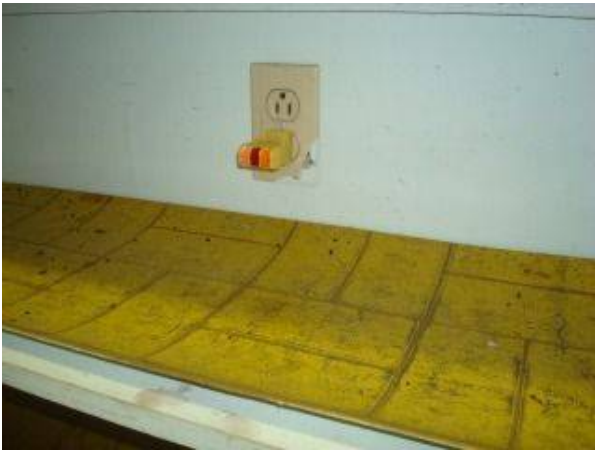
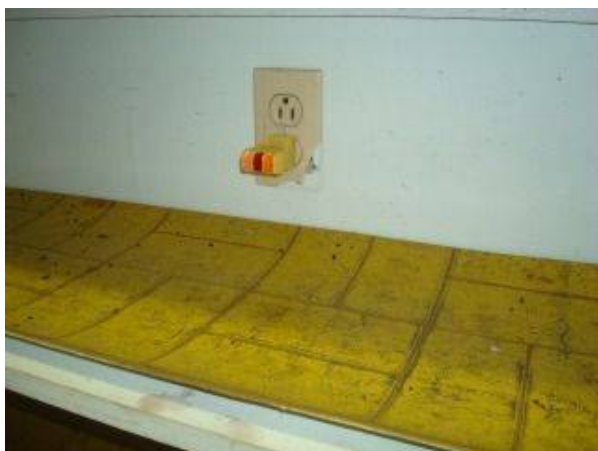
Photo 15-1

- One or more cover plates for switches, receptacles or junction boxes were missing or broken. These plates are intended to contain fire and prevent electric shock from occurring due to exposed wires. Recommend that a qualified person install cover plates where necessary.

One or more cover plates for switches, receptacles or junction boxes were missing or broken. These plates are intended to contain fire and prevent electric shock from occurring due to exposed wires. Recommend that a qualified person install cover plates where necessary.

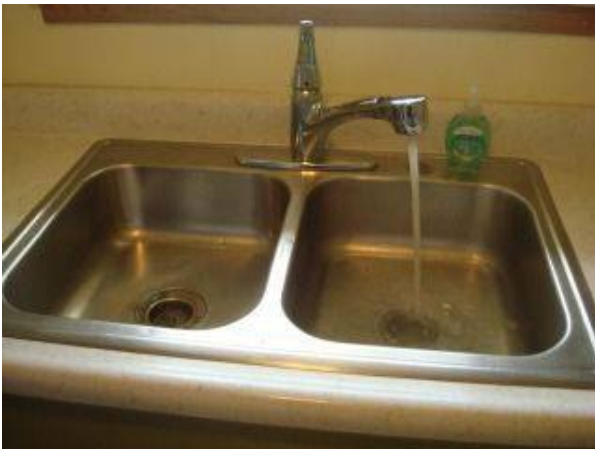
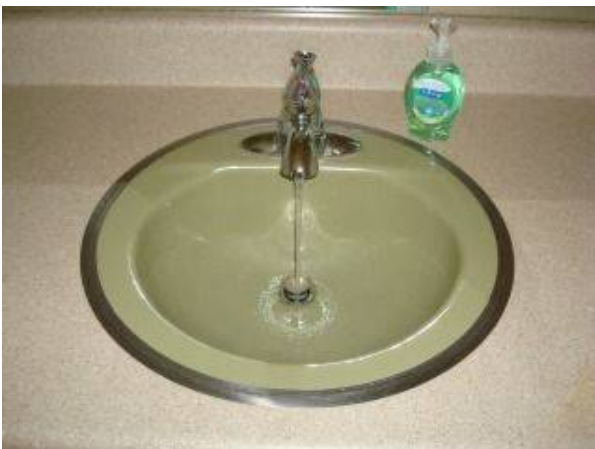
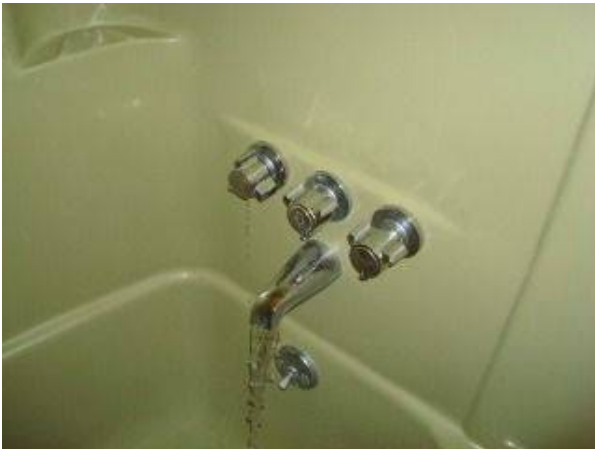
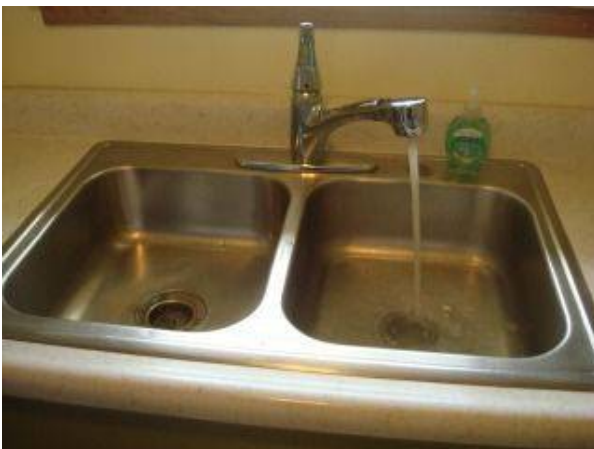
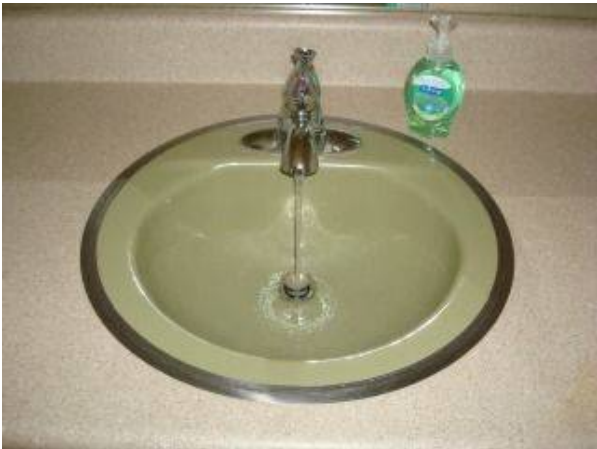
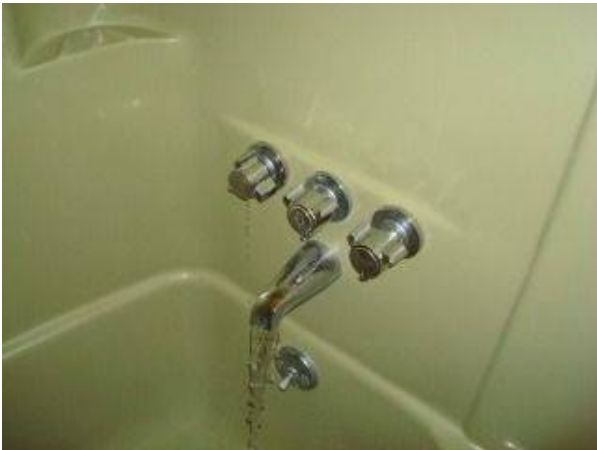
- Low flow was found at one or more sinks and/or bathtubs when multiple fixtures were operated at the same time. Recommend that a qualified plumber evaluate and repair as necessary.

Low flow was found at one or more sinks and/or bathtubs when multiple fixtures were operated at the same time. Recommend that a qualified plumber evaluate and repair as necessary.

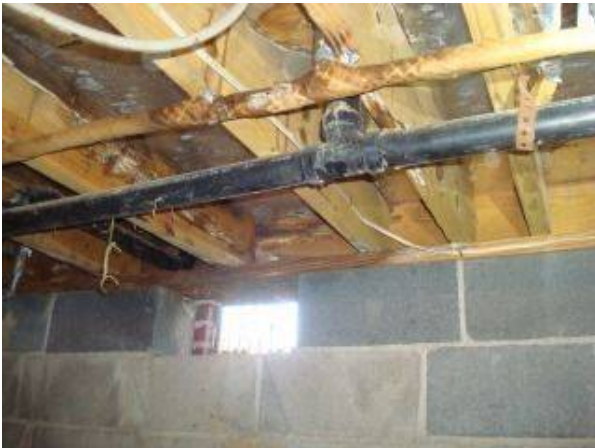
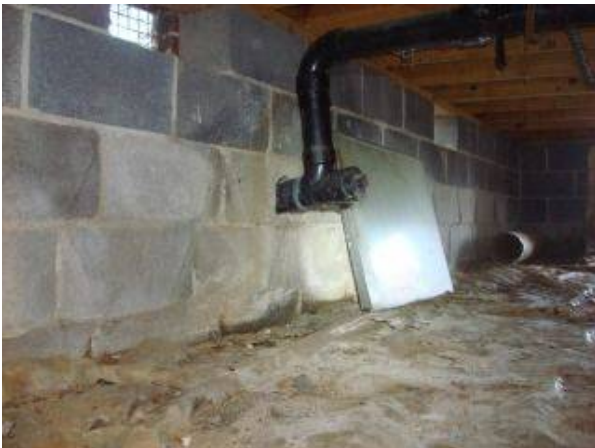
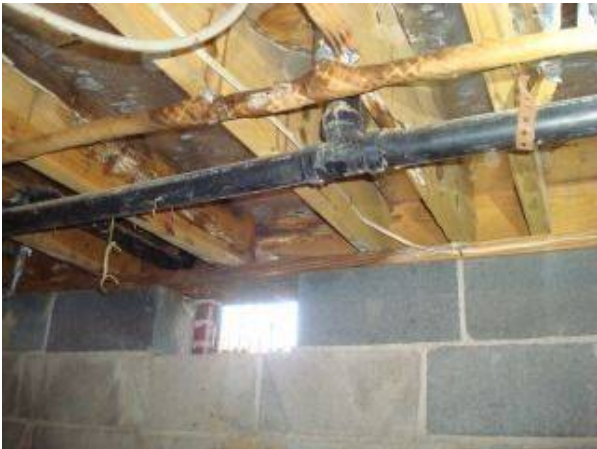
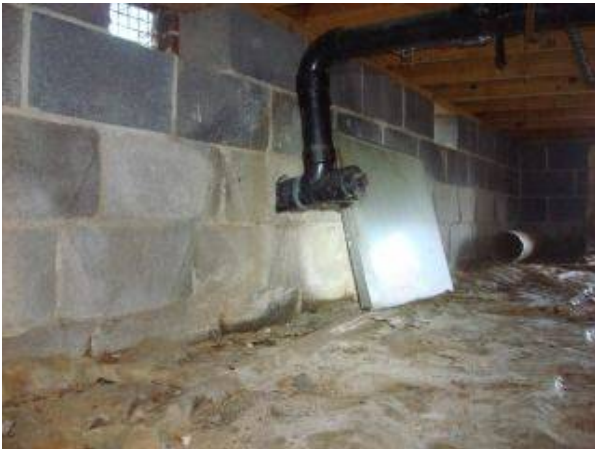
- One or more leaks were found in drain and/or waste pipes or fittings. A qualified plumber should evaluate and repair as necessary.

One or more leaks were found in drain and/or waste pipes or fittings. A qualified plumber should evaluate and repair as necessary.

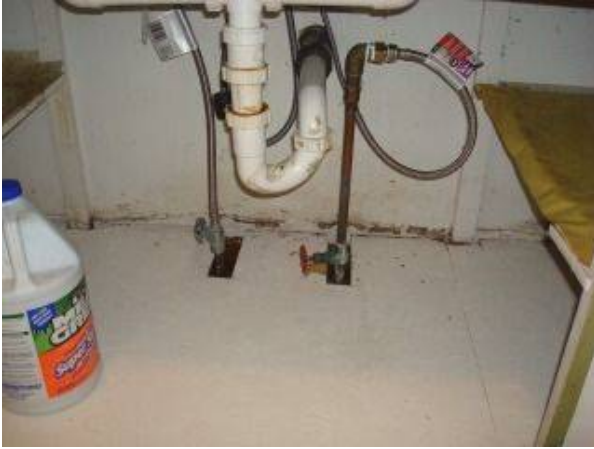
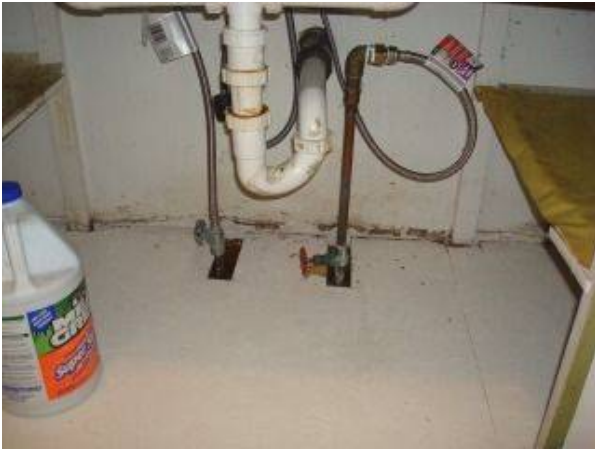
Photo 24-1

- One or more sink drains were leaking. A qualified plumber should repair as necessary.

One or more sink drains were leaking. A qualified plumber should repair as necessary.

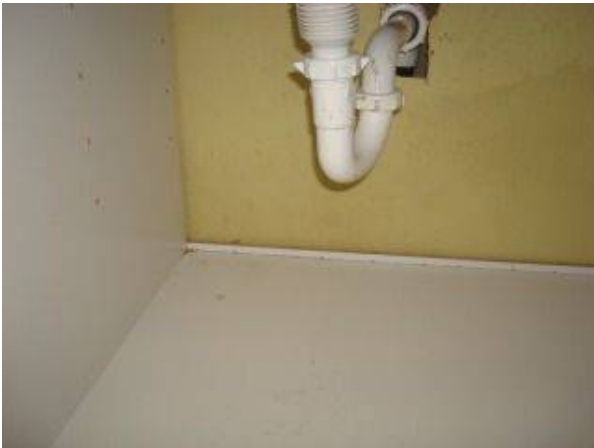
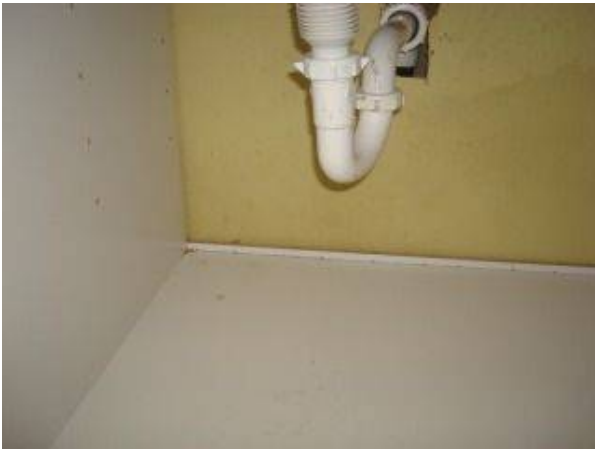
Photo 25-1

- One or more sink drains were leaking at location(s) #A. A qualified person should repair as necessary.

One or more sink drains were leaking at location(s) #A. A qualified person should repair as necessary.

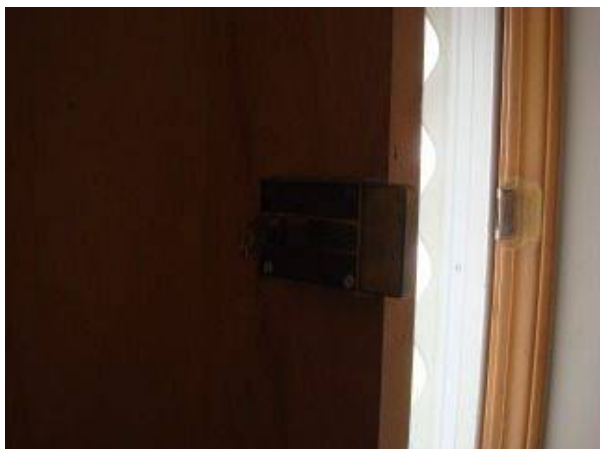
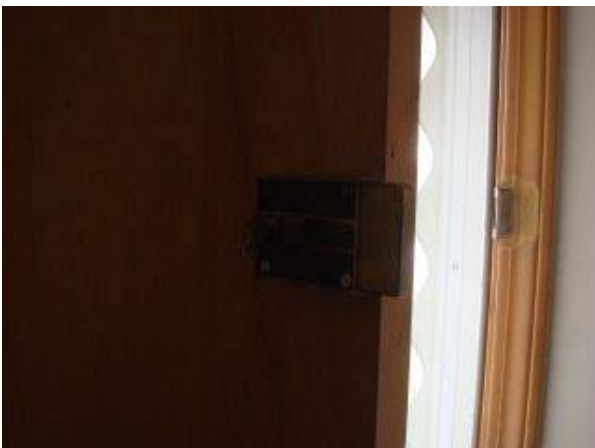
Photo 27-1

- One or more exterior doors had double-cylinder deadbolts installed, where a key is required to open them from both sides. This can be a safety hazard in the event of an emergency because egress can be obstructed or delayed. Recommend replacing double-cylinder deadbolts with single-cylinder deadbolts where a handle is installed on the interior side.

One or more exterior doors had double-cylinder deadbolts installed, where a key is required to open them from both sides. This can be a safety hazard in the event of an emergency because egress can be obstructed or delayed. Recommend replacing double-cylinder deadbolts with single-cylinder deadbolts where a handle is installed on the interior side.

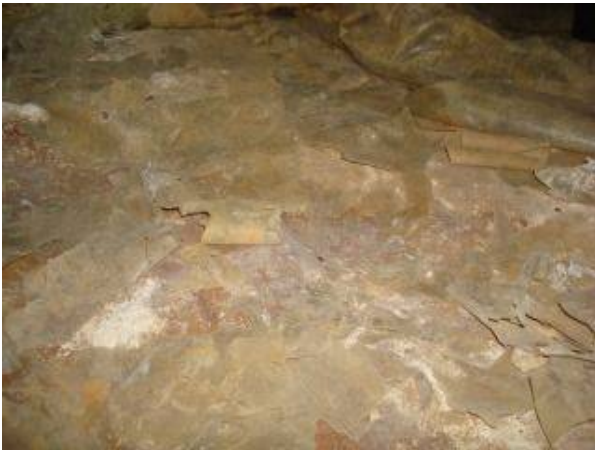
Photo 4-1

-
- 4) Vapor barrier in crawlspace was loose and torn in places. Recommend repairing the vapor barrier.
