Hensley Home Check, LLC

Summary

Client(s): **Mr. And Mrs. Homebuyer**
Property address: **111 Anywhere, USA**
Inspection date: **Sunday, April 17, 2016**

Property Inspection Report

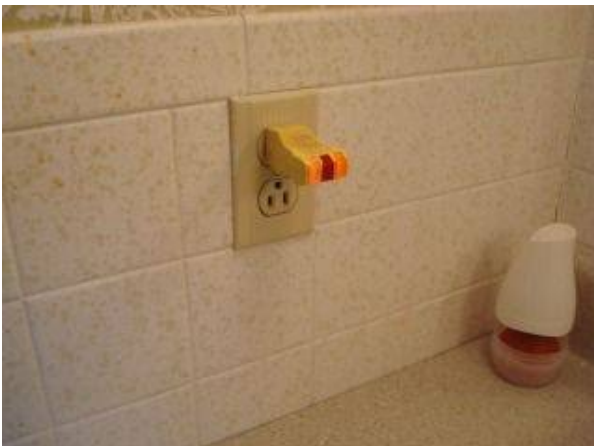
Photo 12-2

- One or more electric receptacles at the kitchen, full bath and/or garage had no visible ground fault circuit interrupter (GFCI) protection. Receptacles within six feet of interior plumbing fixtures, and all receptacles in the garage or carport, and on the exterior of the home should be GFCI protected. If not GFCI-protected, receptacles in wet areas pose a shock hazard. Recommend that a qualified electrician evaluate and install GFCI protection if necessary and per standard building practices.
